Temperature and moisture evolution beneath an aerogel based rendering applied to a historic building

Aerogel based rendering
Restoration
Historic building
External rendering
Vapor permeability
Random stone wall

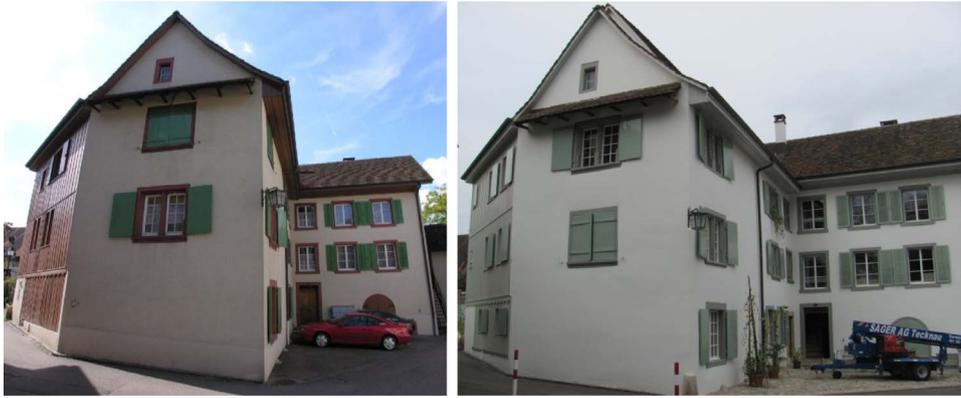
Fig. 1. Eastern façade of the building before retrofit with the portland cement rendering (left) and after retrofit with the new aerogel based rendering (right).

At a first glance the external application of the aerogel based rendering does not seem adequate for restoration of listed buildings as its ingredients do not comply with those of a historical rendering and moreover there is the necessity to use a glass fiber reinforcing mesh to compensate for temperature induced stress. Nevertheless, the approval for this pilot project was given first because there was no historic rendering on the façades and second under the strict condition that the thickness of the new rendering does not exceed the thickness of the old one. This made it possible for the stone frame of the windows to continue clearly to protrude and act as decorative elements. Even under these restrictive preconditions the aerogel based rendering enabled an efficient thermal insulation of the façade. Hence, the rendering allowed an external insulation compatible with the overall appearance of the building. Due to the thin layer needed, window and door frames as well as other typical design characteristics essential for a distinctive appearance of a building in the locality remained completely visible after the retrofit procedure.

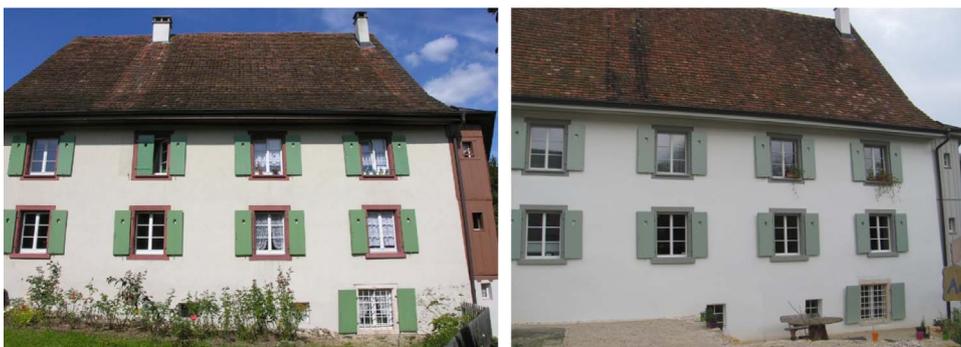
Fig. 2. Southern façade of the building before retrofit with the portland cement rendering (left) and after retrofit with the new aerogel based rendering (right).

The investigated mill is situated in the historic town center of Sissach in Canton Basel-Landschaft belonging to the flatlands of north-western Switzerland. The mill of Sissach is listed in the Federal Inventory of Swiss Heritage Site (ISOS) by the Swiss Federal Office of Culture (FOC) as of national importance. The oldest parts of the mill date back to the 14th century. Throughout the centuries, a complex building arose with an impressive pitched roof so that its architectural substance represents an important testimony of the historic character of the town center of Sissach. The present-day shape and size has remained nearly unchanged since 1672. It was in 1905 that for the last time grain was milled to flour and since then the mill was turned into a residential building. It was used as a dwelling for workers of a nearby silk ribbon weaving mill, a major industry in Switzerland during the early years of the 20th century. In 1974, the building was subjected to its latest renovation. The old historical rendering on the external side which had been in a ruined state and covered with metal sheets was removed and replaced by a very hard Portland cement rendering. This was possible because at that time only the appearance of the building was of interest to the state office for the preservation of monuments and the original materials and production techniques were not a concern. This circumstance allowed the removal of the above-mentioned external rendering in 2012 without compromising the conservation rules and replacing it with the present aerogel based insulation rendering consisting of mainly mineral ingredients. Nevertheless, all kind of changes on the façade remained subject to tight restrictions hence, forbidding any conventional external insulation right from the beginning. Fig. 1 shows the eastern façade of the building before and after the new retrofit respectively. The same is shown for the southern façade in Fig. 2. Today the dwelling is inhabited by 13 people living in 6 apartments spread over three floors.

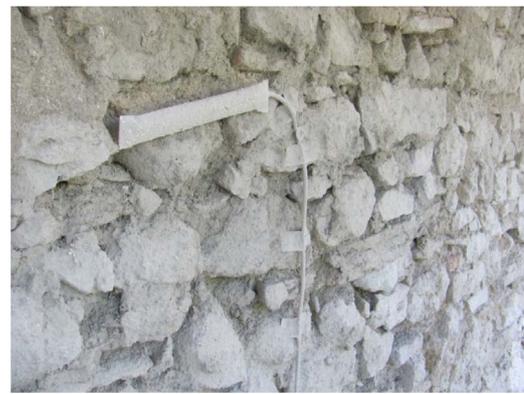
Fig. 6. Position of the air and humidity sensor on the wall before applying the highly insulating aerogel based rendering.

- The surfaces of the random stone walls are very uneven due to different stone sizes used (Fig. 6). It is obvious that applying an external rendering will not result in a homogeneous thickness of the latter as it would be the case for modern concrete or brickwork walls. This means that for an average value of 50 mm on top of the external walls fluctuation of ± 10 mm might occur. This unevenness

causes at the same time a large uncertainty for the position of the sensor which has to be considered in the numerical simulations by varying the distance between the sensor and the surface of the original wall.
